Flood Control Project Maintenance

2008 Structure Summary Report

Reclamation District No. 0999

Elk Slough Inlet Structure

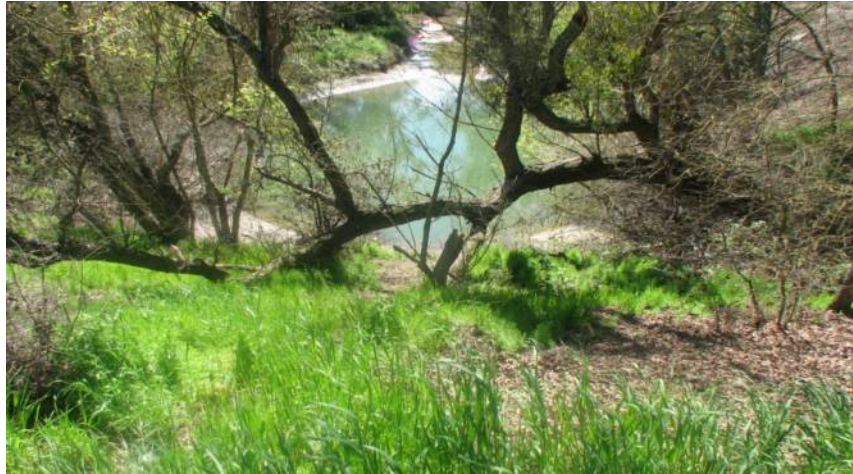
Report Line	4
Location	
Category	Structures & Concrete Lined Channels
Item	Culverts: Inlets / Outlets

Looking at discharge side of Elk Slough. The structure is under water.

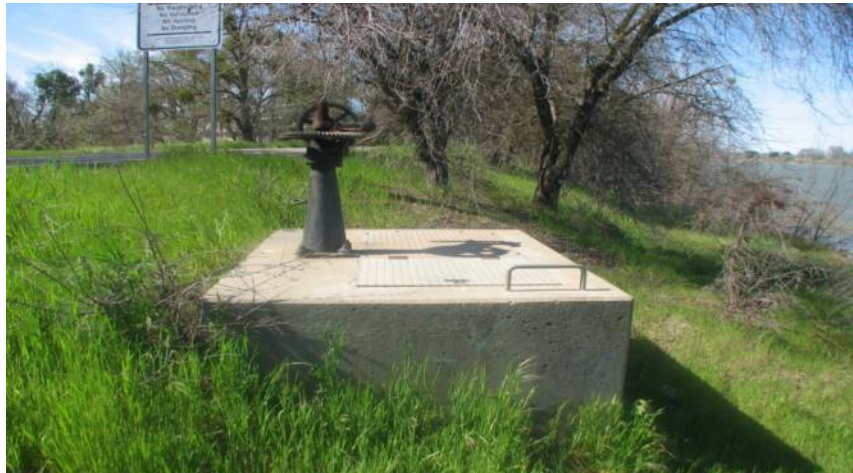
Report Line	5
Location	
Category	Structures & Concrete Lined Channels
Item	Manual Operations

Looking upstream at gate control mechanism box

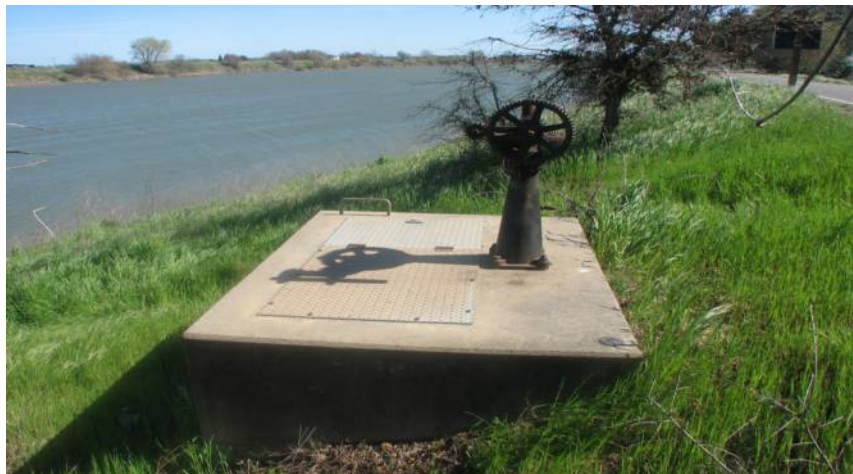
Report Line	5
Location	
Category	Structures & Concrete Lined Channels
Item	Manual Operations

Looking downstream at gate control mechanism box.

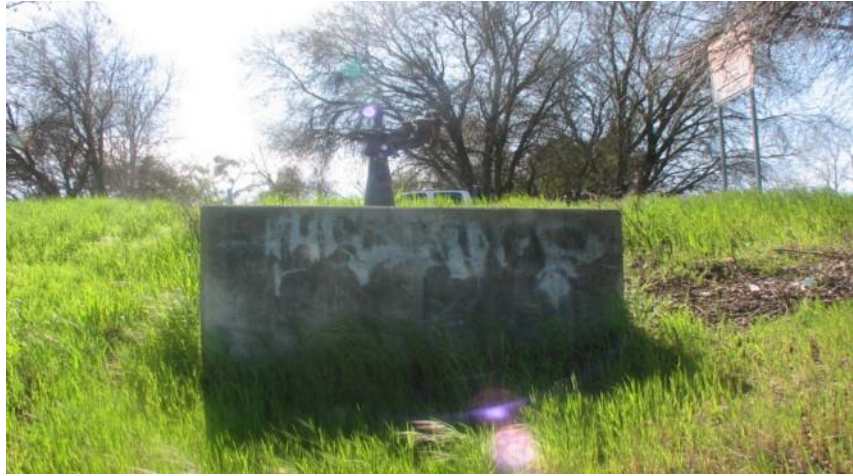
Report Line	5
Location	
Category	Structures & Concrete Lined Channels
Item	Manual Operations

Looking westward at mechanism box.
